TECHNICAL INSPECTION REPORT

U.S.S. WILSON (CDD408)

TEST ABLE [U].

OPERATION CROSSROADS.

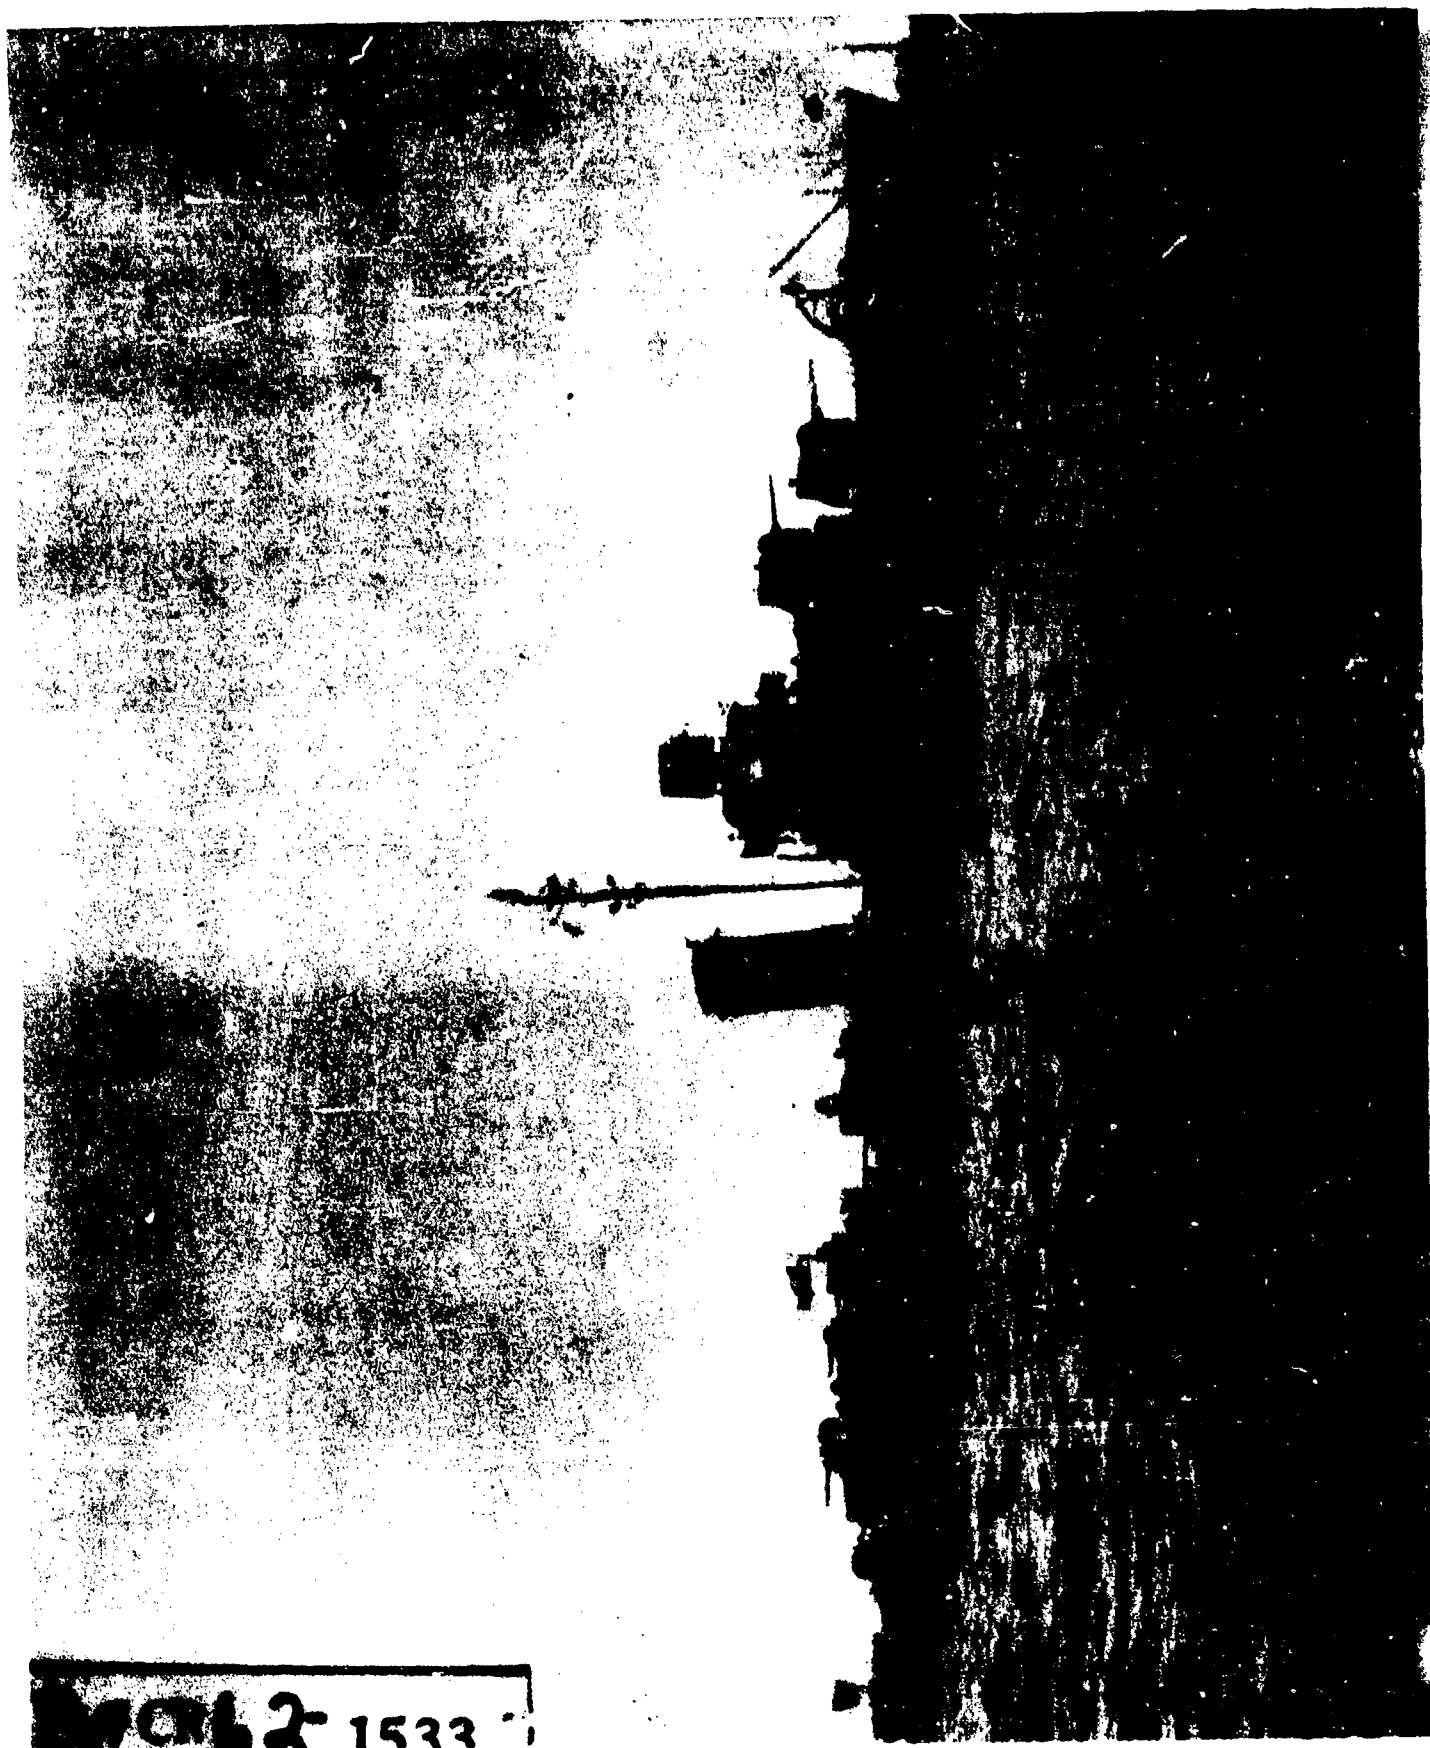
BA-CR-62-1533-7. View from off starboard beam.

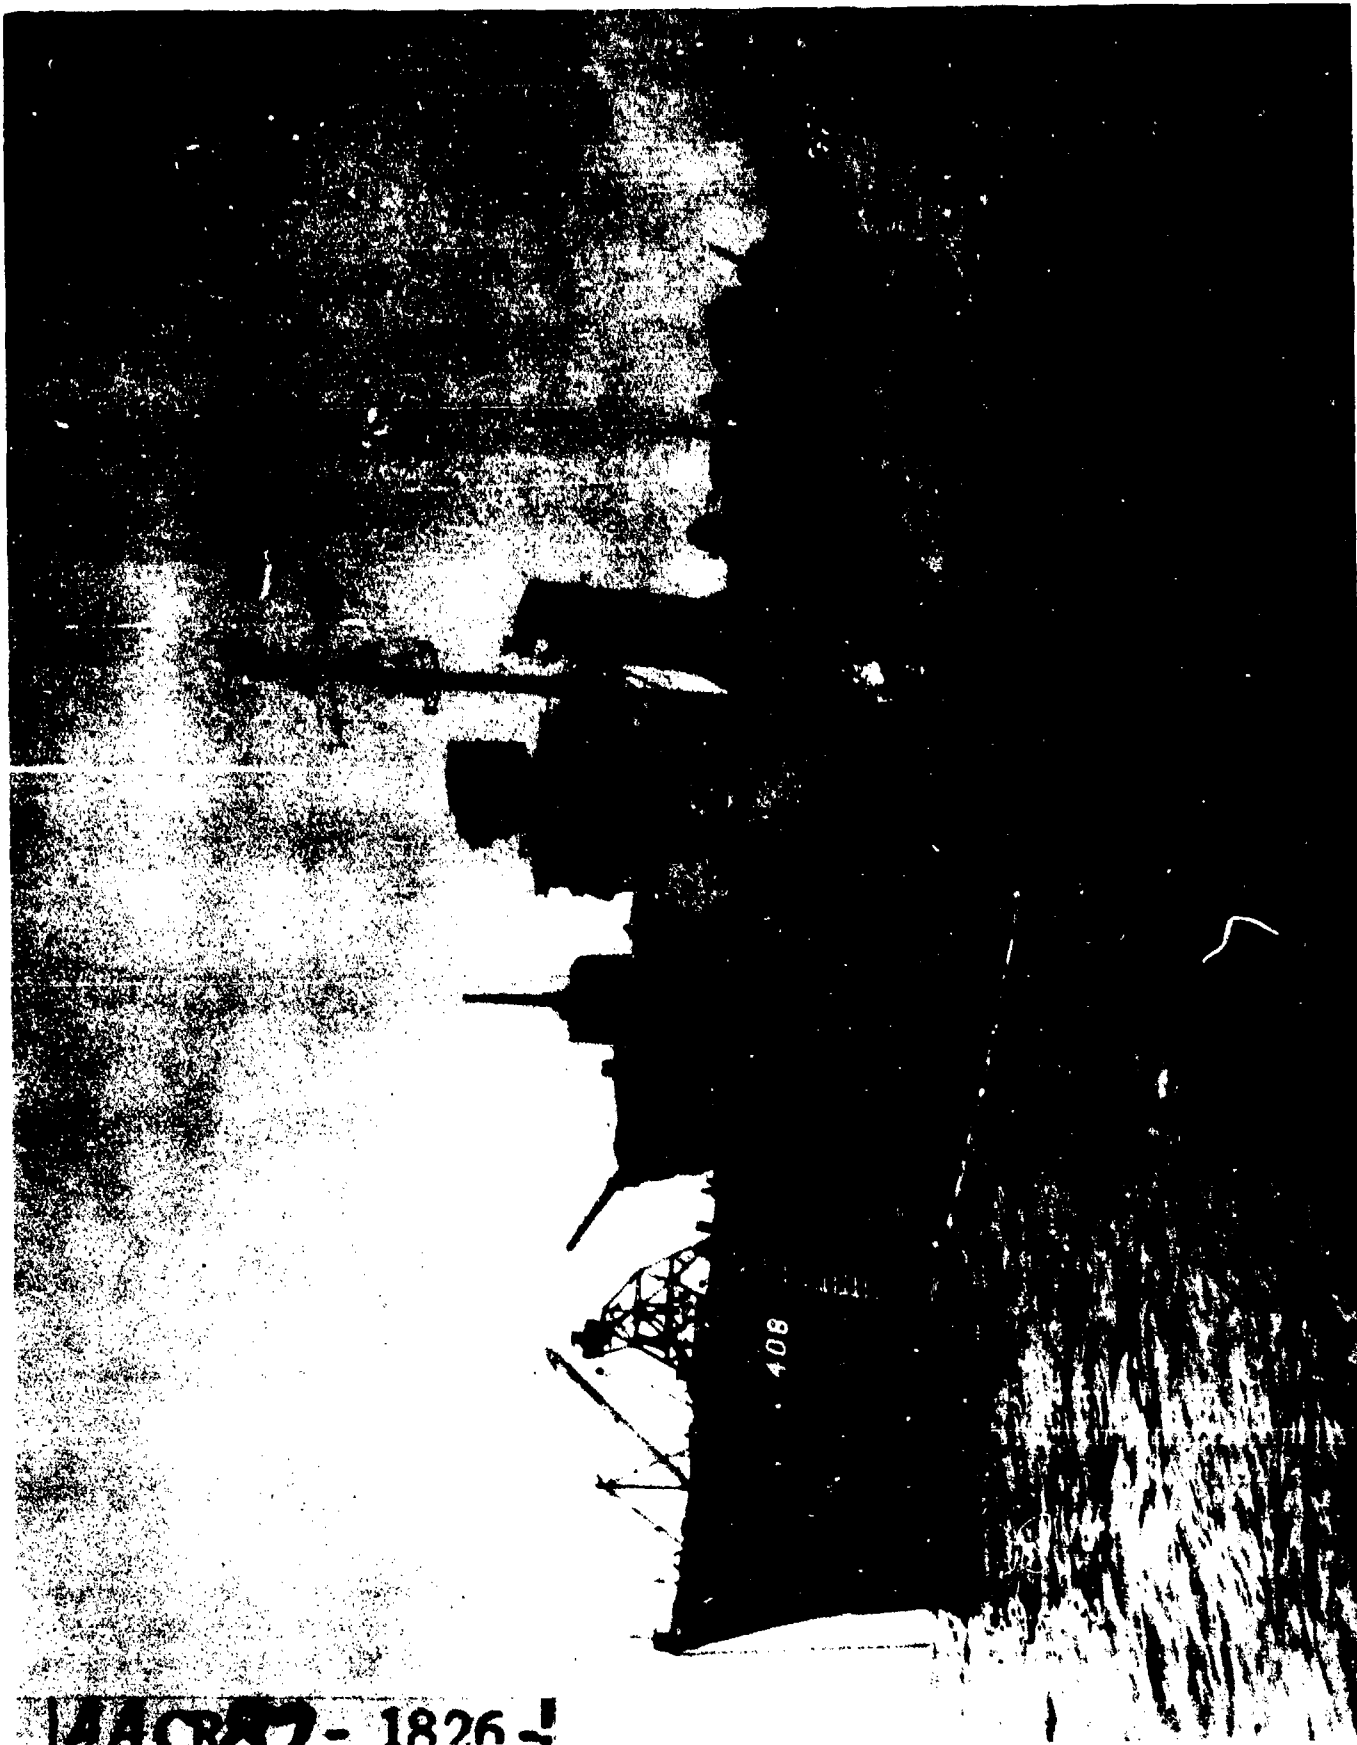
AA-CR-82-1826-7. View from off port bow.

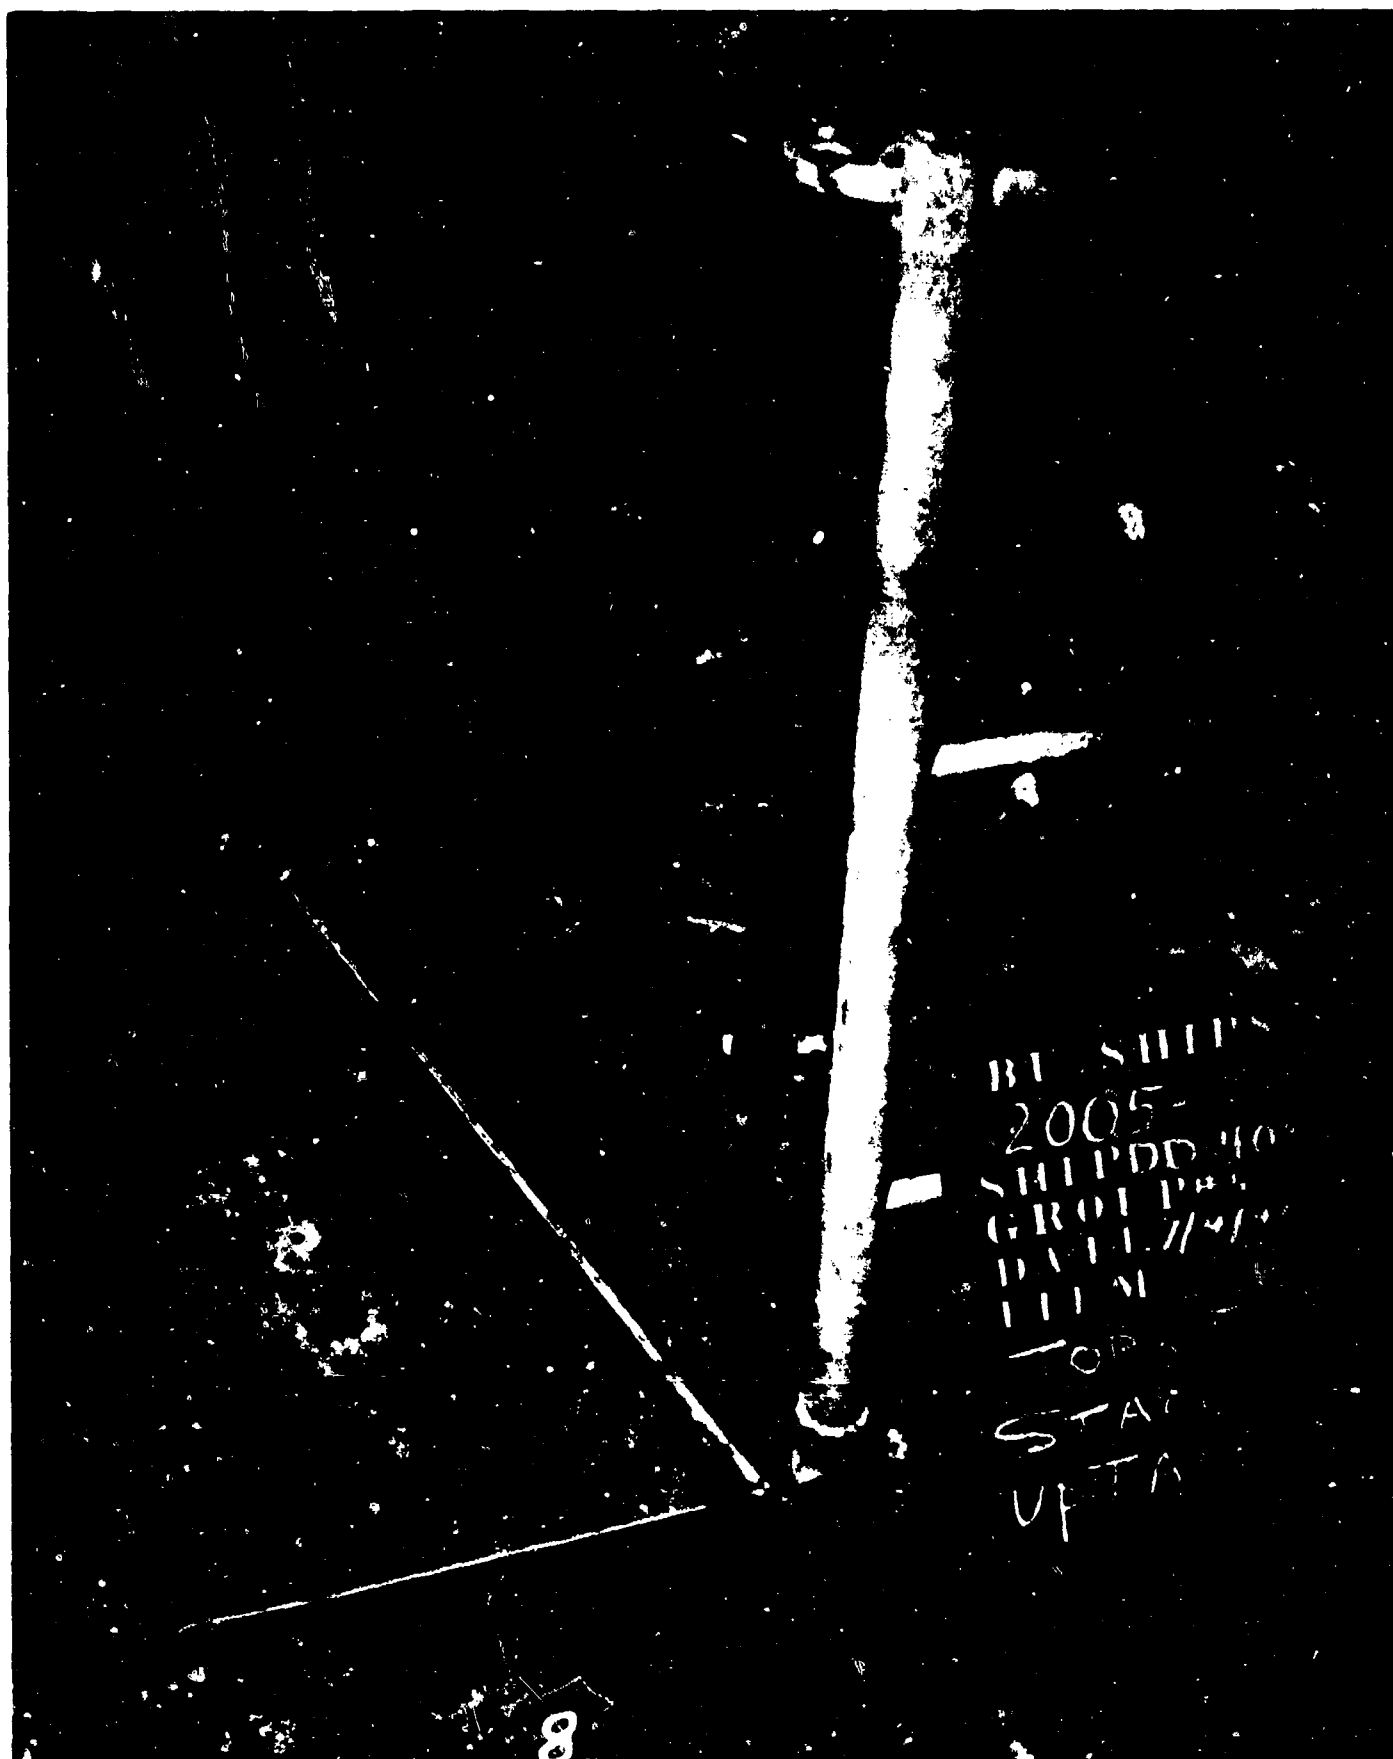
AA-CR-58-2005-8. Damage to top of stack breeching looking aft.

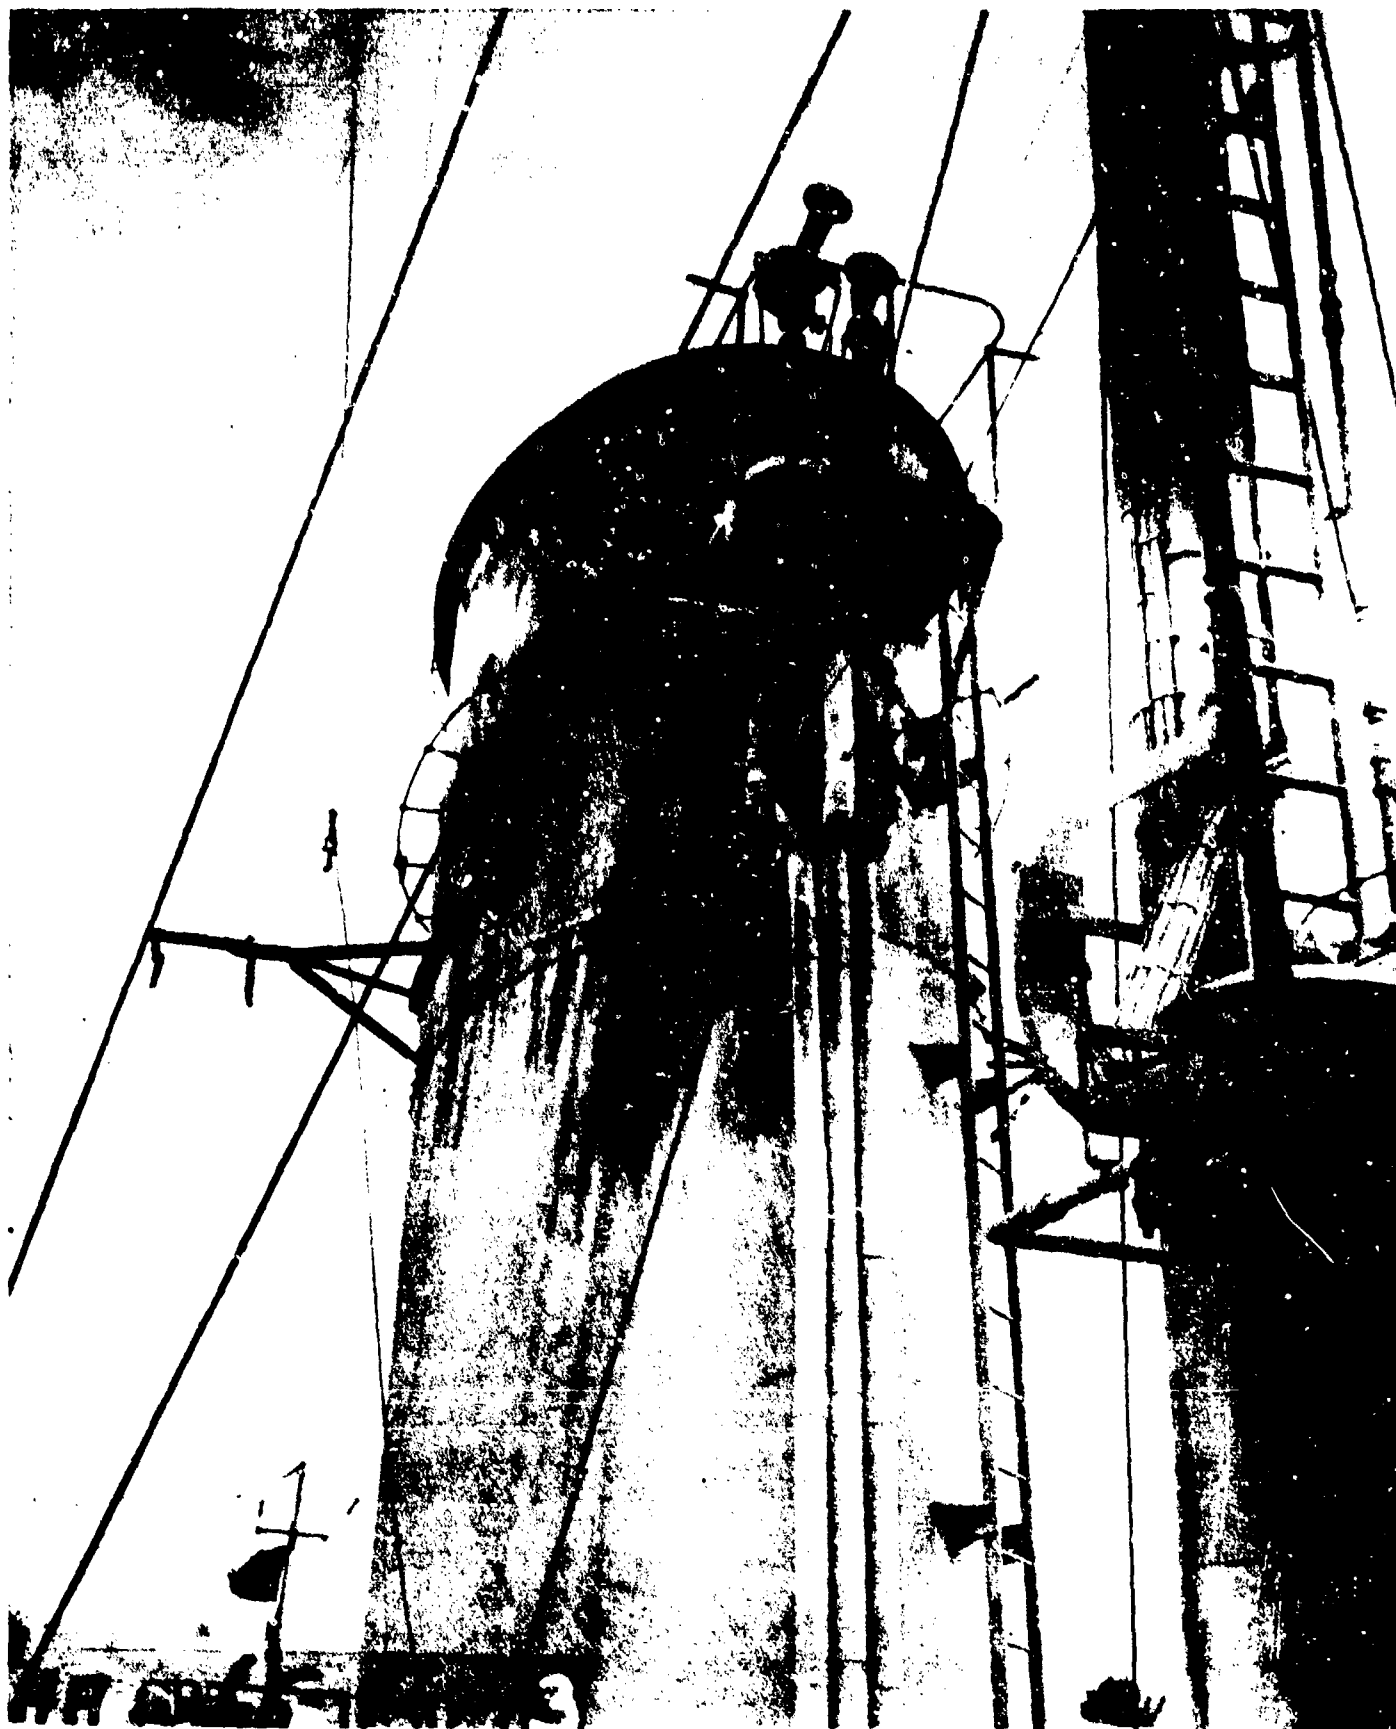
AA-CR-65-1850-3. Looking aft and to port, showing paint damage on stack.
